CASE STUDY: GAS PIPELINE**LOCATION:** WEST MIDLANDS UK**MARKET:** UTILITIES

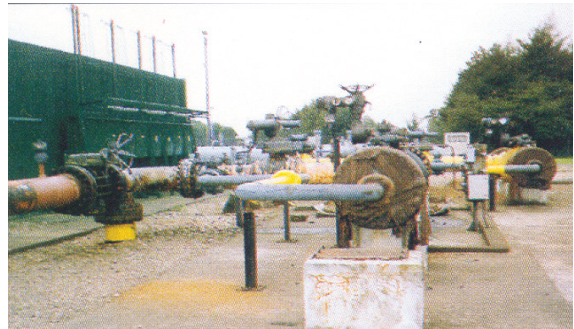
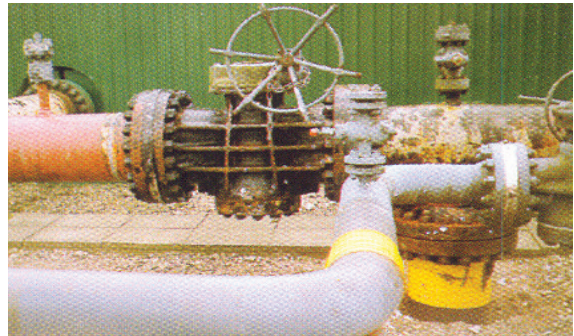
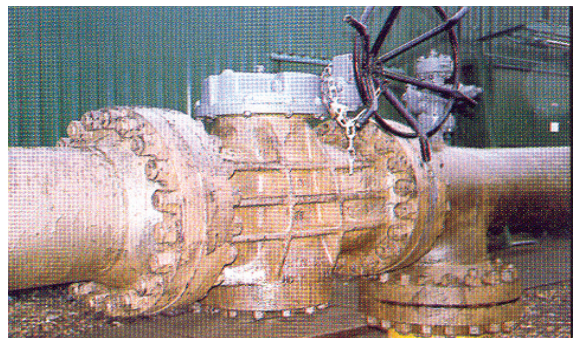
REQUIREMENT: Despite the well insulated and aluminium clad section of the PRS pipeline, significant corrosion was detected on the outer surface of the inner pipe, caused by surface condensation due to low gas temperatures and humid conditions in a highly aggressive environment. The above ground gas pipe (steel) required coating to prevent further corrosion of pipes, valves and flange bolts while remaining in service. An expected life of 10 years before first maintenance was also required. The Corroless system was recommended to meet these requirements.

COMMENTS: This work was carried out and inspected 11 years later and was found to be in very good condition, with no further inspection intended for a further 4 to 5 years. The previous system had lasted for only 7 years.

SURFACE PREPARATION: The pipes were hydrojetted and manually prepared to St2 standard of EN ISO 8501-1:2007 and then hydrojetted again to remove any further dust and contamination.

COATINGS: The pipes were patched prime with Corroless EPF followed by two full coats of Corroless EPF.

PRODUCT:	DFT
Corroless EPF Black	patch prime
Corroless EPF Buff	200 microns
Corroless EPF Black	200 microns
