CASE STUDY: COASTAL SWING BRIDGE**LOCATION:** NORTH YORKSHIRE UK**MARKET:** BRIDGES**REQUIREMENT:**

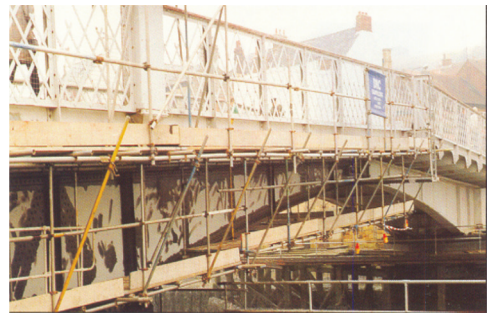
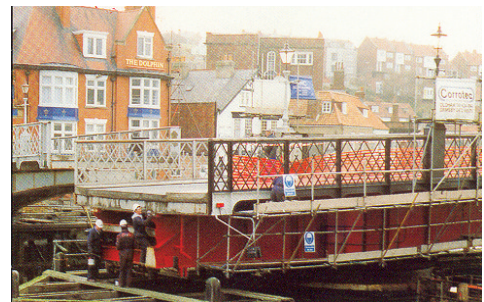
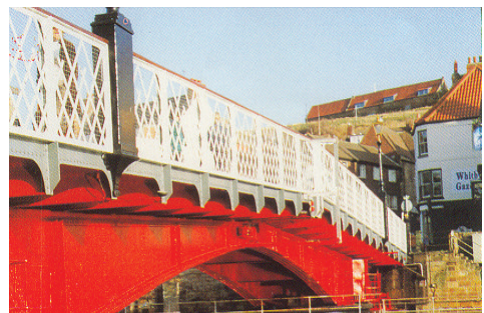
Refurbishment of the Swing Bridge over river in a coastal environment. Customer wanted long term protection without interfering with day-to-day traffic both on the road over the bridge and on the river under the bridge. The swing bridge was to remain fully functional. The structure was corroding with particular problems on bolt heads and edges.

This work was carried out and inspected 11 years later and was found to be very good condition with no further inspection intended for a further 4 to 5 years. The previous system had lasted for only 7 years.

The structure was manually prepared to St2 standard of EN ISO 8501-1:2007 followed hydrojetting to remove salt contamination. The surface was allowed to dry before coating.

A patch prime and full coat of Corroless EPF were followed by two full coats of Corroless RF65.

DFT (per coat)
Corroless EPF Black (Patch)	200 microns
Corroless EPF Buff	200 microns
Corroless RF65 Red	50 microns
Corroless RF65 Red	50 microns
