CASE STUDY: FAIRGROUND EQUIPMENT**LOCATION:** NORTH YORKSHIRE UK**MARKET:** GENERAL MAINTENANCE**REQUIREMENT:**

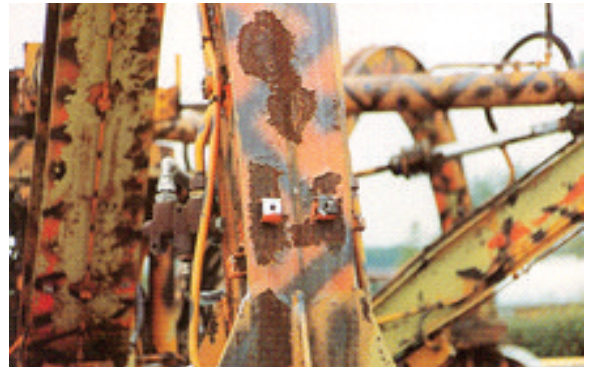
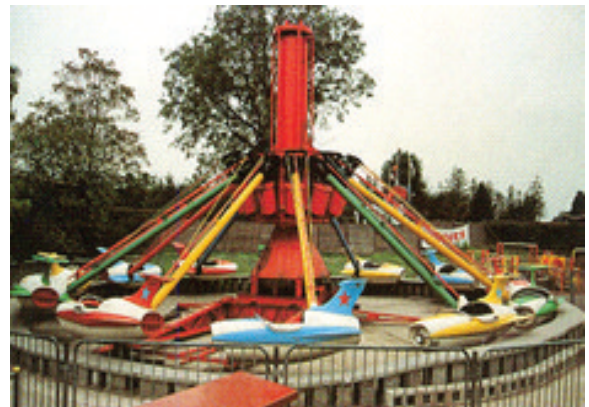
Severe breakdown of existing coating on fairground rides. Customer wanted long term protection without the need to blast clean the steel. Lead free products were also a requirement.

Surfaces were degreased and then hand prepared to St2 standard of EN ISO 8501-1:2007, washed with fresh water and allowed to dry.

Coats of Corroless S1 and S2 were followed by a topcoat of Corroless RF16.

Edges, welds, nuts and bolts were stripe coated before applying each full coat.

PRODUCT	Colour	DFT
Corroless S1	Red Oxide	35 microns
Corroless S2	Buff	35 microns
Corroless RF16	Varied	50 microns
