CASE STUDY: COOLING WATER SCREEN

LOCATION: Petroleum Refinery, Cyprus

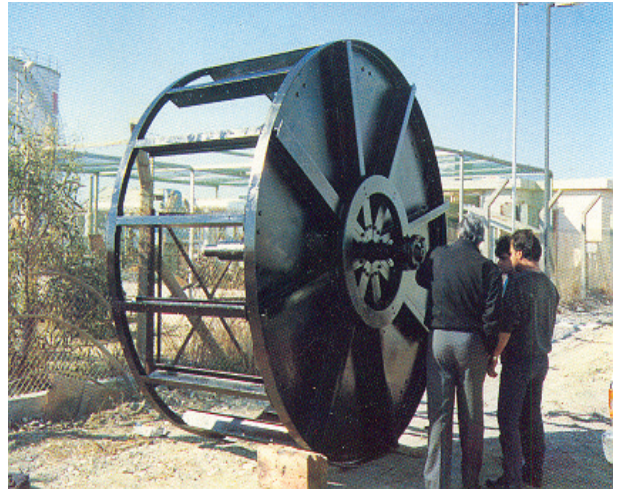
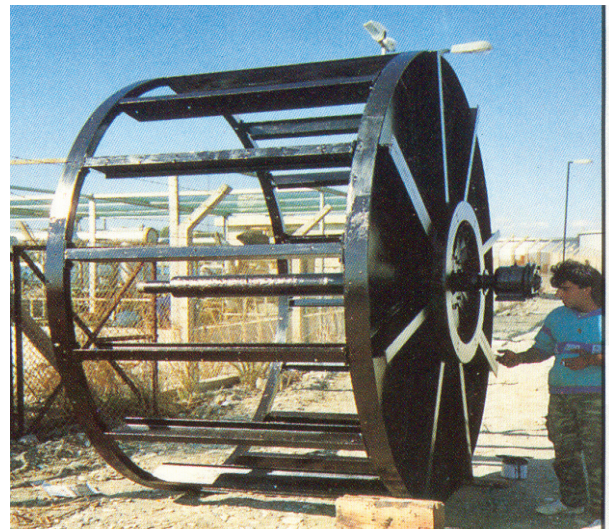
The Screens were pressure washed with fresh water to remove any salt contamination prior to blast cleaning to Sa2½ of ISO Standard EN ISO 8501-1:2007 to a profile of 50 to 75 microns. Preparation was completed by a further fresh water wash to remove any dust created.

Two coats of Corroless EPF were applied

PRODUCT	DFT (per coat)
Corroless EPF Buff	200 microns
Corroless EPF Black	200 microns

The screens were put back into service and the performance compared with a screen coated with a competitor's product. The competitor's product failed after two months. The screens coated with Corroless EPF were still in perfect condition after 18 months, at which the customer adopted the Corroless system as standard.
