Paint Defects Manual

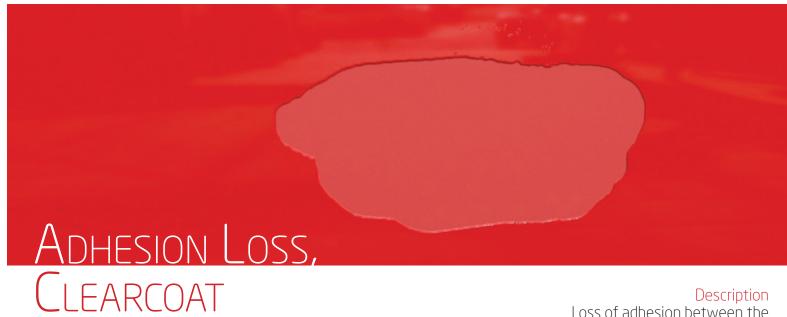
Loss of adhesion between the basecoat and the clearcoat.

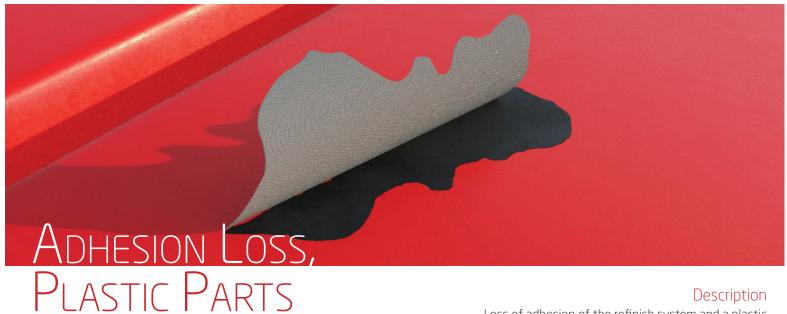
Loss of adhesion of the refinish system and a plastic part substrate. This defect is often noticed some time after the painting took place.

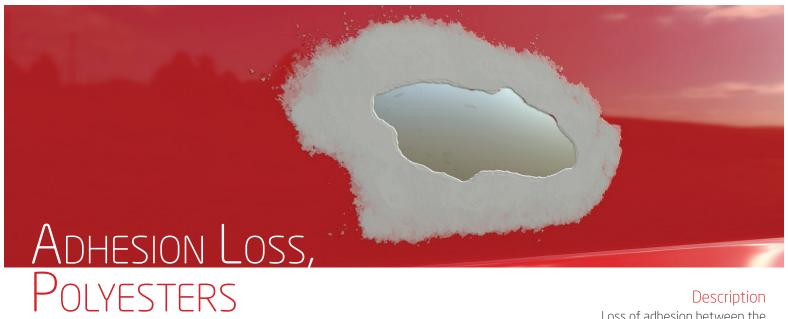
Loss of adhesion between the polyester filler and the substrate.

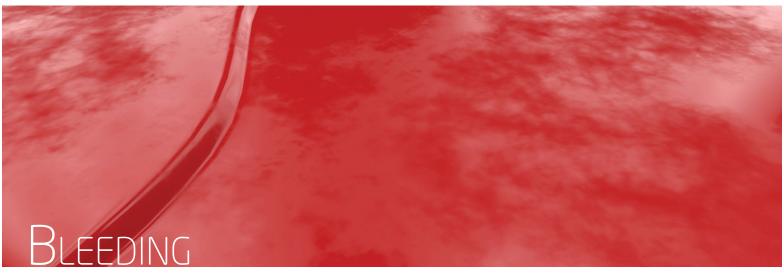
Also known as: bleed through, staining, stains

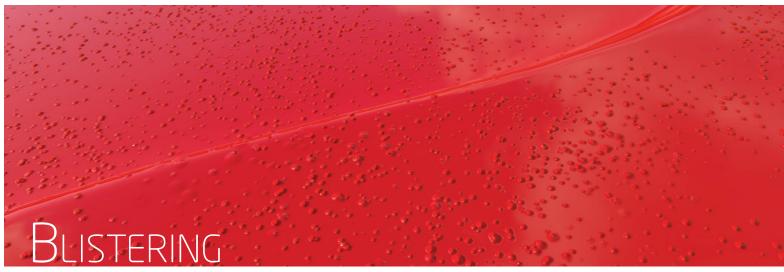
Also known as: moisture blisters, bubbling, blowing, bubbles

Description
Bubbles or pimples appearing in the topcoat film, application.

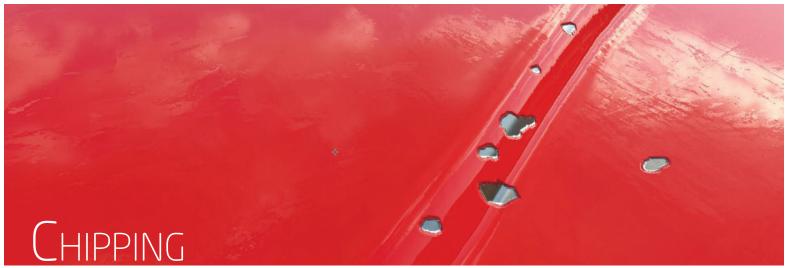
Small chips of a finish losing adhesion from the substrate, usually caused by impact of stones or hard objects against the vehicle's finish. While the refinisher has no control over local road conditions, he can take steps to minimize their effect the condition is known beforehand.

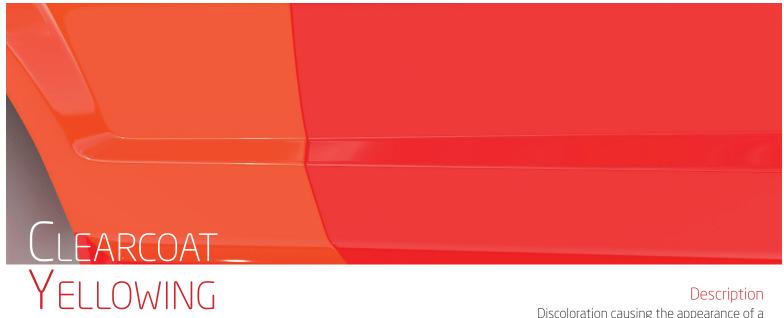
Discoloration causing the appearance of a color mismatch to the adjacent panel after the clearcoat is applied.

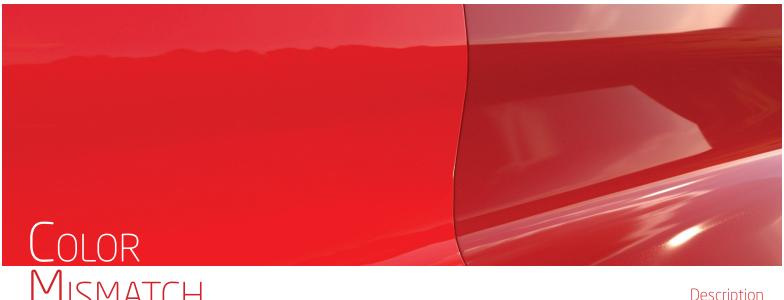
Also known as: off shade, mismatch fading, off color

The color of the repaired part differs from that originally on the object being painted.

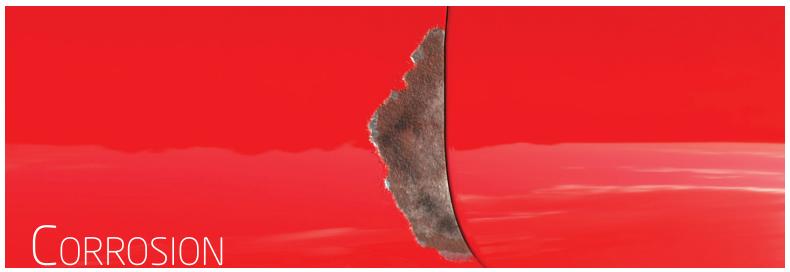
Surface of metal substrate is visible and shows corrosion spots. Brownish-red for steel, white rust in the case of aluminum substrates.

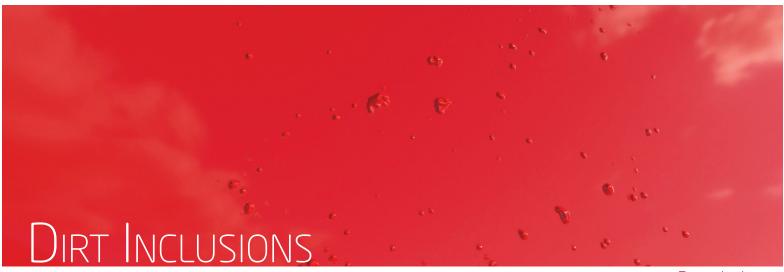
Also known as: bits, dirt in paint, seed, grains, specks, spikes, grits

A surface with this defect will show particles of different sizes deposited in the primer or color.

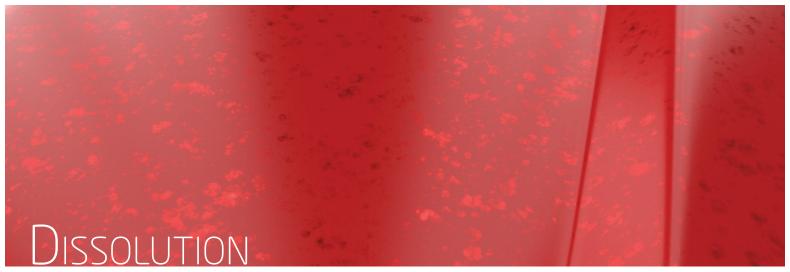
Metallic particles from the basecoat surface in the clearcoat. If severe, the effect can alter the tone and exagerate the metallic appearance.

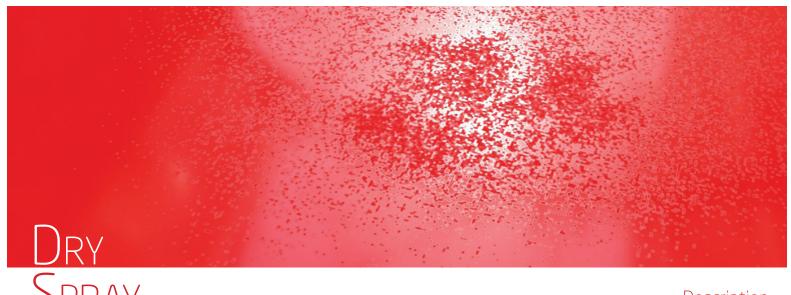
Granular texture normally with no gloss at all. This defect is normally limited to small areas.

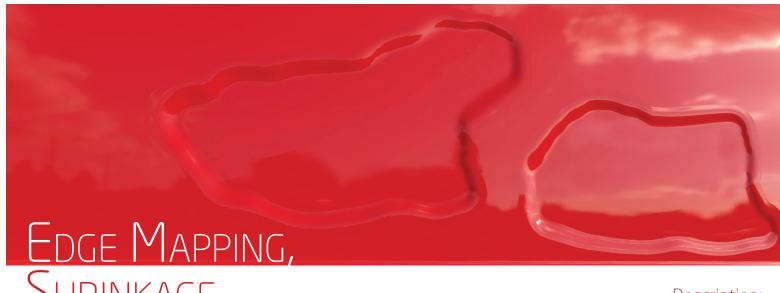
Also known as: featheredge splitting

Enlarged sand scratches caused by shrinking action of primer layers that held excess solvent into the basecoat or topcoat application, appearing at the area of the repair where it was sanded through to the substrate.

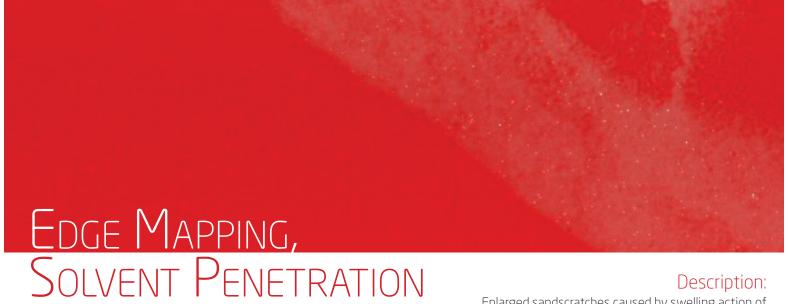
Also known as: Sandscratch swelling, tramlining, lining up, flattingmarks, sanding marks, scratch swelling

Enlarged sandscratches caused by swelling action of topcoat solvents, appearing at the area of the repair where it was sanded through to the substrate.

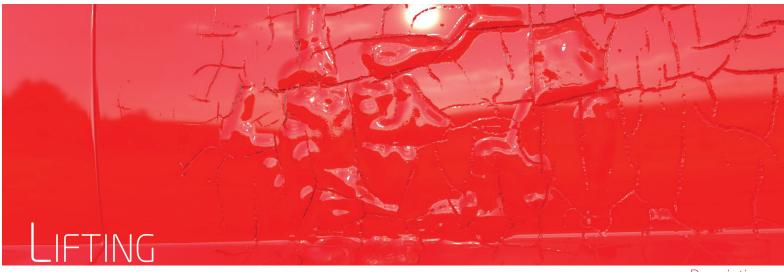
Also known as: wrinkling, rippling, raising

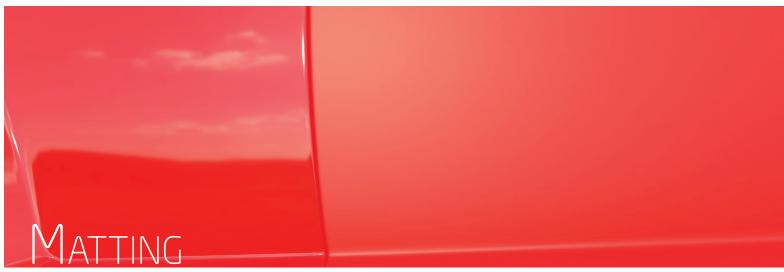
Also known as: loss of gloss, dieback

Description Loss of initial gun gloss after finish has dried.

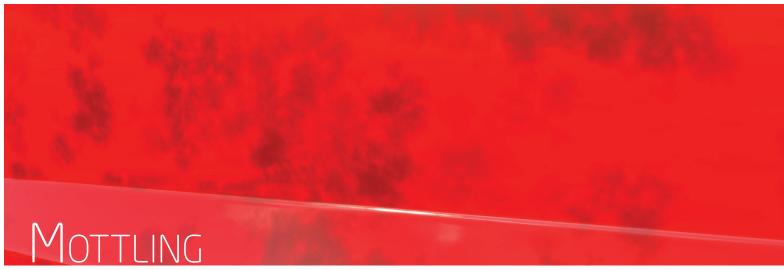
Also known as: striping, banding, shadowing, flooding, floating, misting, precipitation, blooming, bloom, bleaching

Description Occurs mainly in metallics, when the flakes

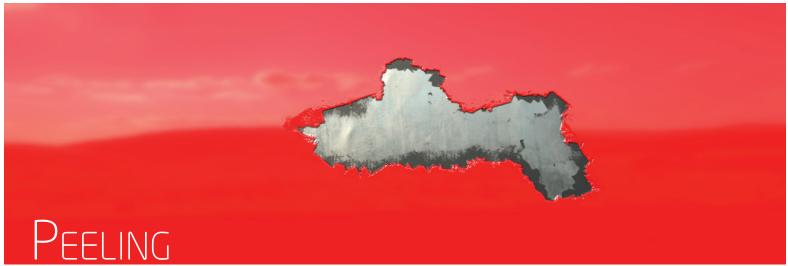
Also known as: loss of adhesion, shelling, poor bond, delamination, flaking, poor adhesion

Loss of adhesion between paint and substrate - topcoat to primer and/or old finish, or primer to substrate.

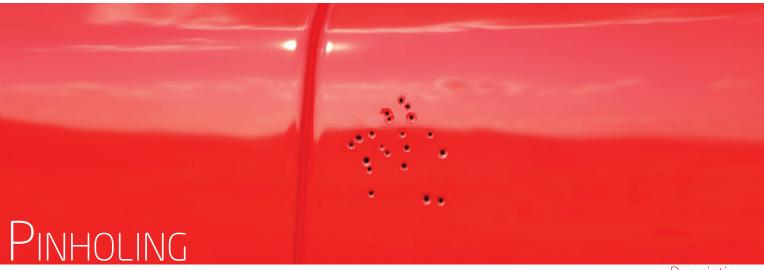
Also known as: pin holes, pock marks, pitting, pops, pin pricks

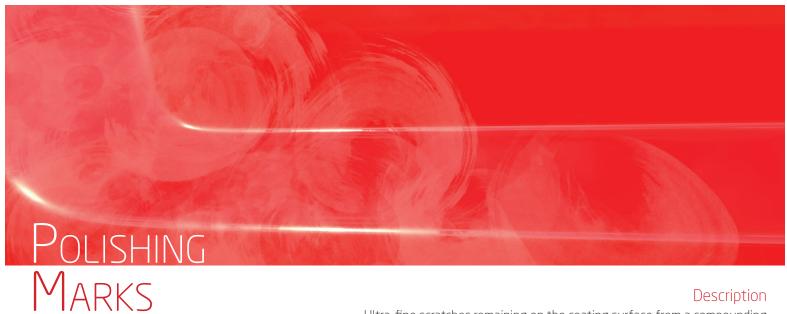
Ultra-fine scratches remaining on the coating surface from a compounding or polishing operation. Can also be fine scratches left in the surface from any preparation sanding performed prior to compounding or polishing.

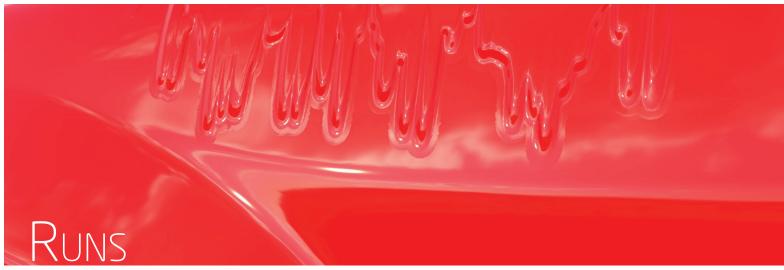
Also known as: overloading, curtains, gun spits, sags, sagging, drips

Description Heavy application of sprayed material that fails to adhere uniformly to the surface.

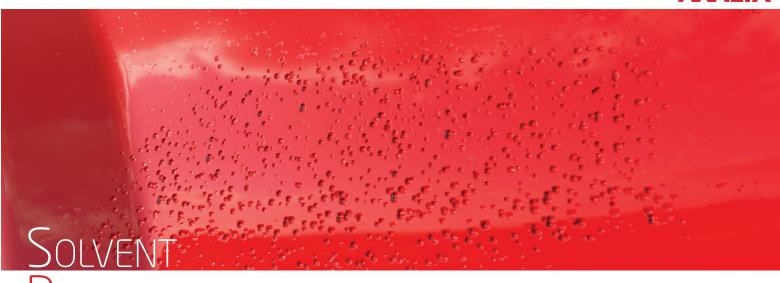
Also known as: Boiling, solvent boil, popping

Description
Solvent that got out too late and could not reheal,
thus leaving a hole in the surface.

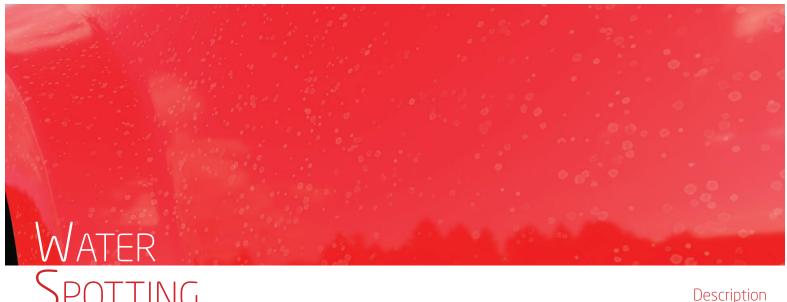
Description
General dulling of gloss in spots or
masses of spots.
