CASE STUDY: AIRCRAFT WING TRAILER PANEL**LOCATION:** UK**MARKET:** AEROSPACE**REQUIREMENT:**

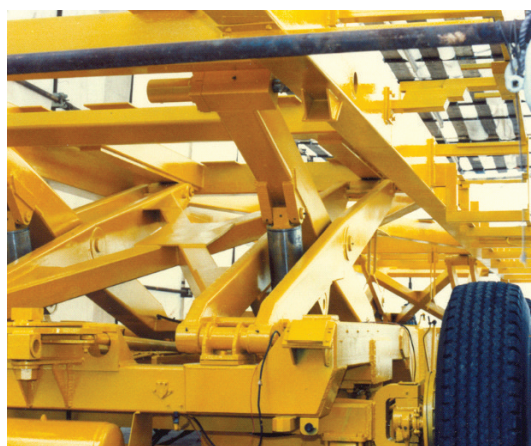
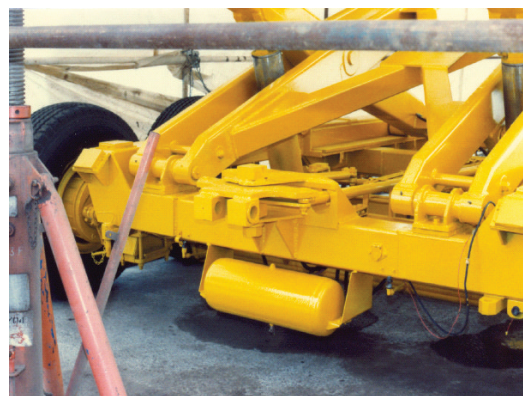
Transporting expensive aircraft wings, the trailers required an extremely tough but decorative high gloss finish, in addition to possessing excellent resistance to aviation fuel. However, the customer was concerned that the external appearance should not be marred by corrosion leaking out of unprotected box sections. As a result CCI Powder was blown into all box sections to ensure the continued anticorrosion protection of all internal surfaces.

The box section was treated with Corroless CCI Powder at 525 g/m³.
