CASE STUDY: FILTRATION EQUIPMENT

LOCATION: SINGAPORE

MARKET: UTILITIES

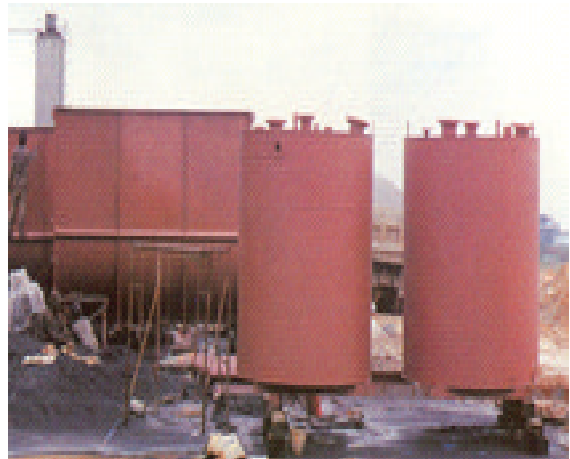
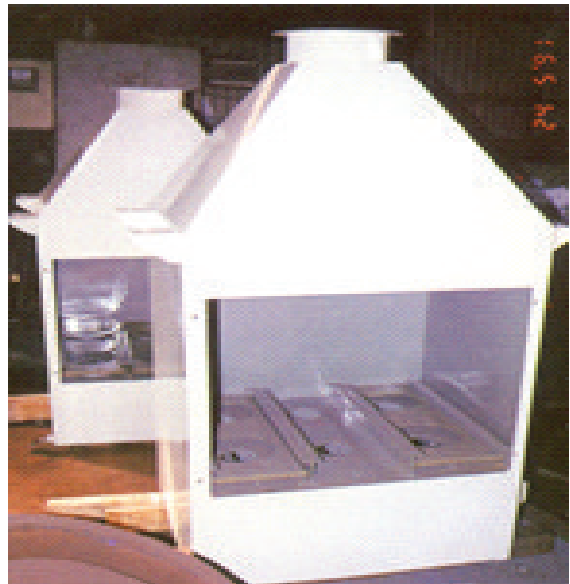
When the client decided to install new filtration systems at its Singapore plant, high performance anticorrosion systems were required to protect tanks and equipment that would be subjected to high degrees of abrasion and chemical attack. Lime D-Mixers, Slurry Tanks, Cyclones and Dust Filters were included.

The external areas received two coats of Corroless S followed by one coat of Corroless RF16. For additional protection, all internal areas were protected with a coat of Corroless EPF and one full coat of Corroless RF35 (2006).

The units were blast cleaned to a minimum of Sa2 of EN ISO 8501-1:2007 with a surface profile of 50-75 microns and washed down with fresh water and allowed to dry.

PRODUCT	Colour	DFT
External		
Corroless S1	RedOxide	35 microns
Corroless S2	Buff	35 microns
Corroless RF16	White	50 microns
Internal		
Corroless EPF	Buff	200 microns
Corroless RF35(2006)	Grey	200 microns

The new filtration plant was successfully commissioned.
