**CASE STUDY: POWER STATION STEELWORK**

**LOCATION:** POWER STATION,  
NORTHERN IRELAND

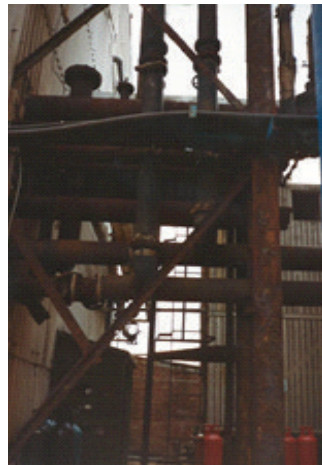
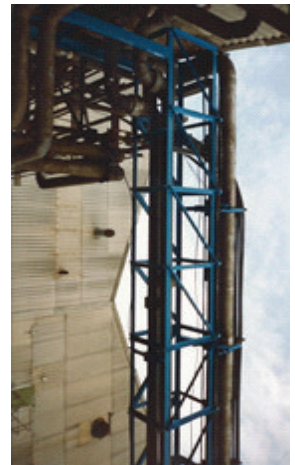
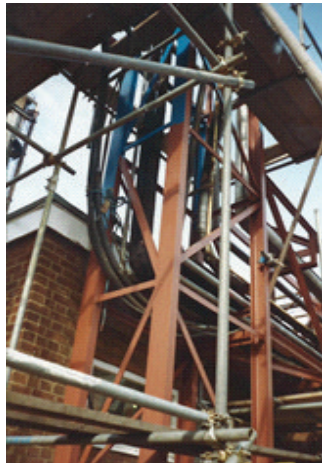
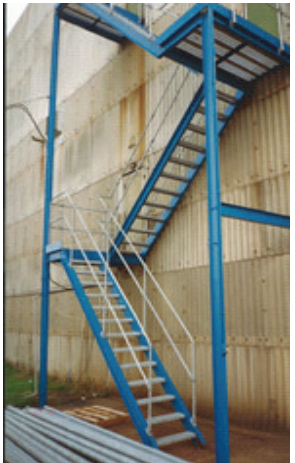
**REQUIREMENT:**  
Recoating of structural steel requiring long term protection.

**PREPARATION:**  
Surfaces were degreased and pressure jetted prior to hand preparing to St2 standard of EN ISO 8501-1:2007. Preparation was completed by a fresh water wash to remove any dust created and the surface was allowed to dry.

**COATINGS:**  
One coat of Corroless EPF followed one full coat of Corroless RF65 with stripe coating where appropriate.

<b>PRODUCT:</b>	<b>DFT</b>
Corroless EPF Buff	200 microns
Corroless RF65 Blue	50 microns
