CASE STUDY: DOCKYARD CRANES**LOCATION:** GREAT YARMOUTH UK**MARKET:** MARINE

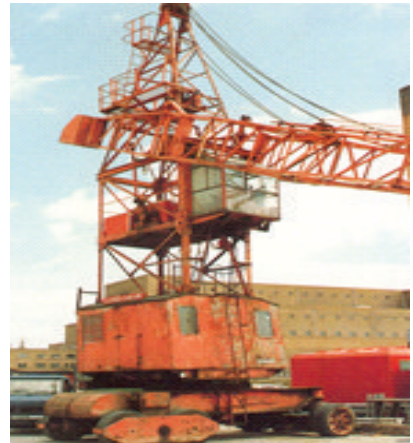
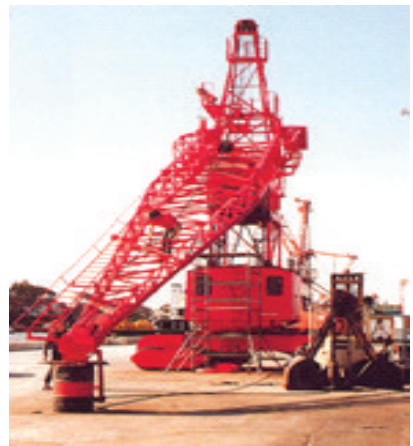
REQUIREMENT: Six dockyard cranes, used extensively in a quayside environment, were showing the usual corrosion problems associated with salt/moisture attack. In a competitive tender situation, it was apparent that competitors were quoting on three and four coat systems.

COMMENTS: A life to first maintenance of 10 years was expected

PREPARATION: Surfaces were degreased and then hand prepared to St2 standard of EN ISO 8501-1:2007, washed with fresh water and allowed to dry.

COATINGS: By using one coat of Corroless S High Build, followed by one full coat of Corroless RF16, substantial labour savings were made, enabling Corroless to win the contract whilst still providing the protection required. Corroless EPF provided the ideal coating for the chassis areas due to its excellent durability and toughness.

PRODUCT	DFT
Super Structure	
Corroless SHB (Buff)	90 microns
Corroless RF16 Red	50 microns

Chasis	
Corroless EPF Buff	200 microns
Corroless EPF Black	200 microns
