CASE STUDY: TOW ROPE AND WINCH**LOCATION:** QUEENSLAND AUSTRALIA**MARKET:** MARINE**REQUIREMENT:**

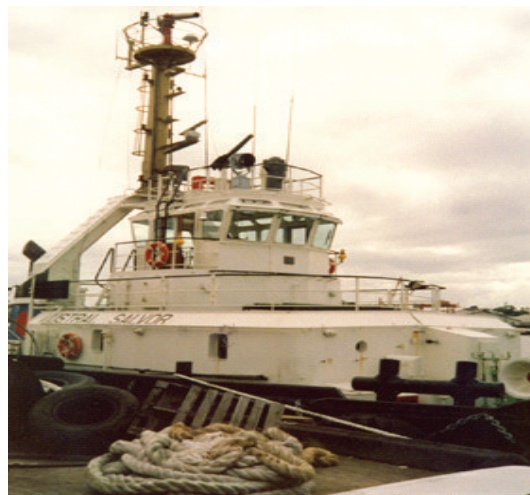
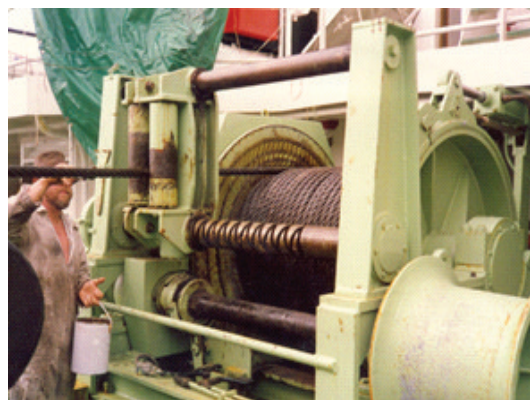
The towrope was laid out on the dock and CCI 350 was applied as it rewound on the drum.

The whole drum and winch assembly was then sprayed with CCI 400.

Corroless CCI 350 Grease
Corroless CCI 400 Wax
