**CASE STUDY: WIRE ROPE****LOCATION:** OFFSHORE**MARKET:** MARINE**REQUIREMENT:**

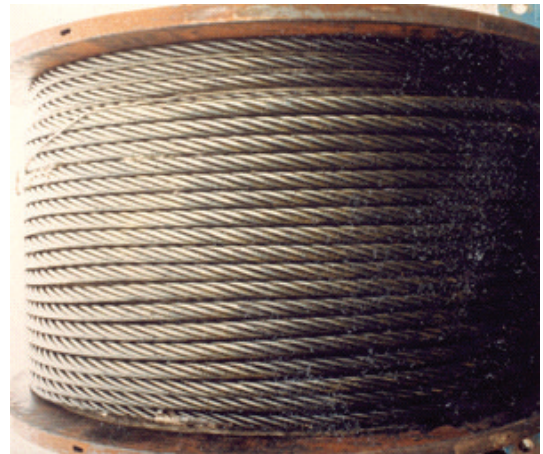
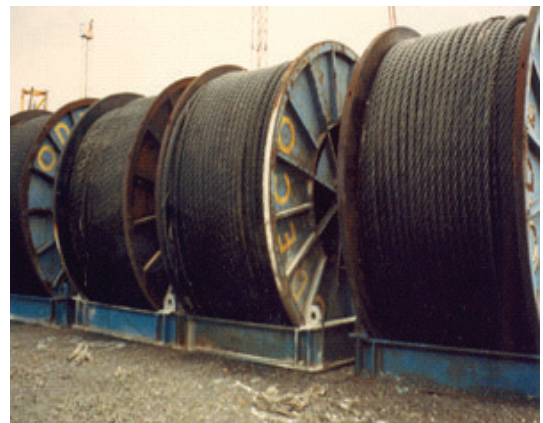
An anticorrosion system for the protection of 12 feet diameter spools of wire rope. Corrosion in wire rope is an extremely difficult problem to control. Whilst the external surfaces may be protected with conventional oils or greases, the inaccessible surfaces of the core can continue to corrode, seriously endangering the integrity of the rope.

Spools were jet washed and allowed to dry and then sprayed with Corroless 350, thinned to facilitate spraying and aid penetration. The special vapour action of Corroless 350 corrosion inhibitor ensures that effective corrosion protection reaches even unexposed and inaccessible surfaces, thereby enhancing both the safety and service life of the wire rope.

The final action was to the whole unit, with Corroless CCI 400 applied overall to complete the protection.
