CASE STUDY: JACK UP SYSTEM

LOCATION: SINGAPORE

MARKET: OFFSHORE

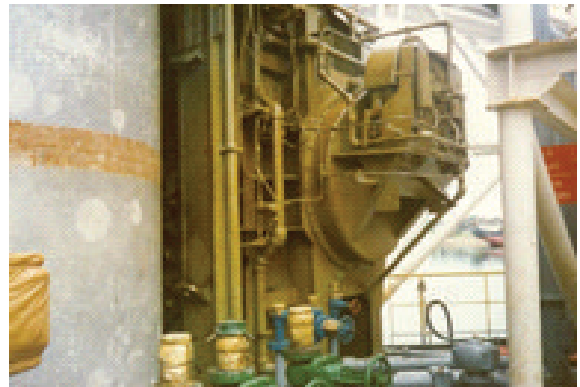
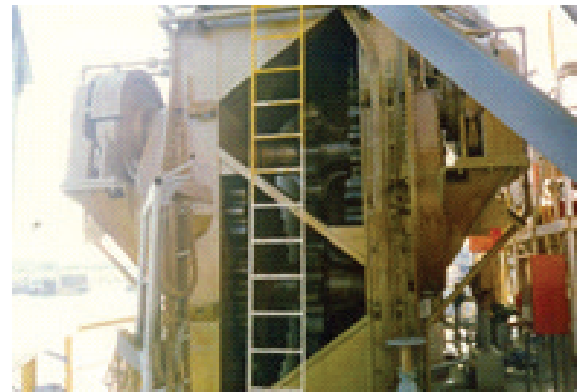
The jack-up system of the rig was showing signs of corrosion and a system was required to provide protection in an aggressive offshore environment.

The surfaces were thoroughly jetted with fresh water and allowed to dry.

Corroless CCI Products were used to provide the necessary protection.

- Corroless CCI 350 was spray applied to the gearing system
- Corroless CCI 400 was spray applied to the external surfaces.

Note: in both cases thinning with up to 20% of Thinners No.2 or similar is necessary to facilitate spraying depending on the ambient temperature.
