CASE STUDY: OFFSHORE DIVING EQUIPMENT

LOCATION: OFFSHORE

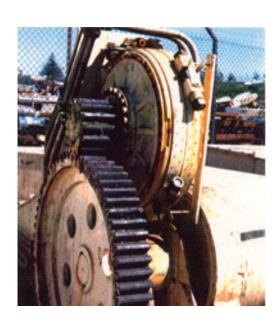
Equipment returning from diving vessels had been allowed to corrode because of lack of care and maintenance.

Units were pressure jetted to remove loose material and salt contamination and allowed to dry.

The hydraulic system was treated with CCI 300M.

All electrical controls were treated with CCI V100 Tape.

Exposed moving parts were lubricated using CCI 350.

All other external surfaces to be protected were sprayed with CCI 400.

This treatment allowed the equipment to be safely stored and swiftly returned to service when required.
