**CASE STUDY: AQUADUCT****LOCATION:** YORKSHIRE**MARKET:** UTILITIES**REQUIREMENT:**

Lining of an Aquaduct and Overflow System providing long term protection.

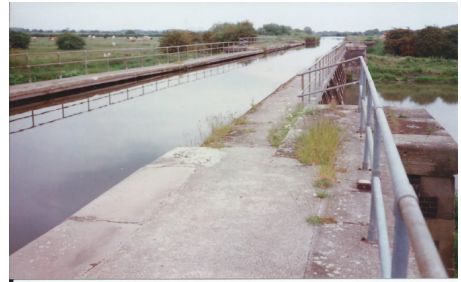
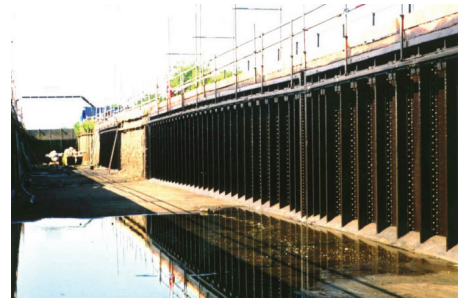
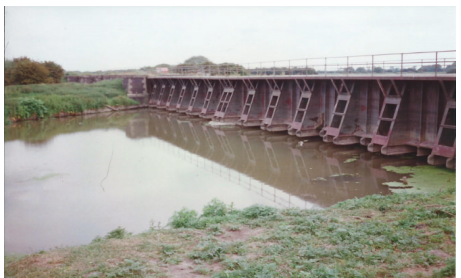
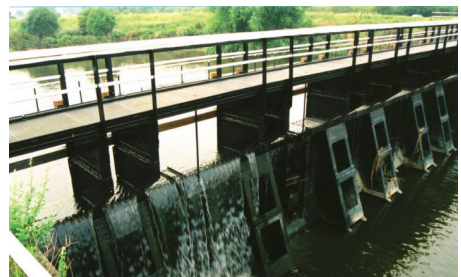
Surfaces: Mild Steel.

Structures were degreased and pressure jetted prior to hand preparation to standard St3 of EN ISO 8501-1:2007, washed with fresh water and allowed to dry.

Two coats of Corroless EPF were applied with stripe coating where appropriate.
