CASE STUDY: ELECTRICITY SUBSTATION**LOCATION:** SCOTLAND**MARKET:** UTILITIES**REQUIREMENT:**

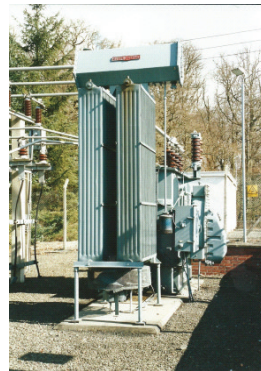
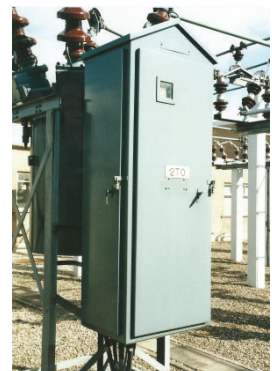
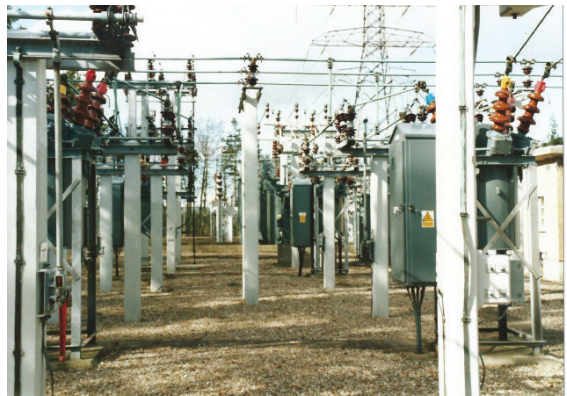
Protection of electrical transformers and other complex equipment from corrosion in an aggressive, exterior exposed environment. Conventional systems had previously given poor performance.

Previously coated and partly corroded steel degreased and hand prepared to St3 standard of EN ISO 8501-1:2007.

Coats of Corroless S1 and S2 Primer were followed by a topcoat of Corroless RF16. A stripe coat was applied where appropriate.

Product	DFT	Colour
Corroless S1	35 microns	Red Oxide
Corroless S2	35 microns	Buff
Corroless RF16	50 microns	Grey

A life to first maintenance of 10 years was expected.
