**CASE STUDY: RESERVOIR VALVE AND SHAFT**

**LOCATION:** YORKSHIRE, UK

**MARKET:** UTILITIES (Water)

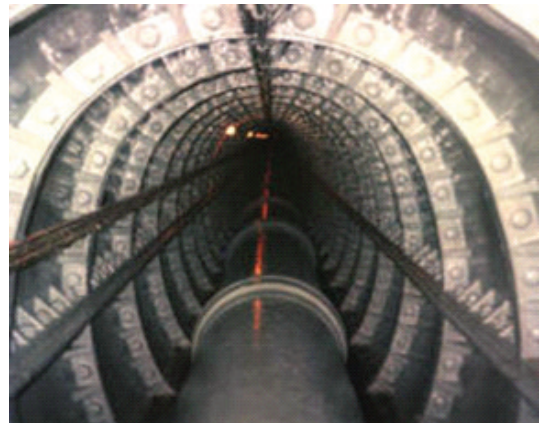
Steelwork was inspected 3 years after application and the coating system was found to be giving excellent protection. A further inspection 8 years after application reported the coating was still in very good condition.

Previously coated and corroded steel: hydrojetted and manually prepared to St2 standard of EN ISO 8501-1:2007 and then hydrojetted again to remove any further dust and contamination.

WRAS approved system of Corroless EPF Buff and Corroless RF35 (2006) was applied. Stripe coating was applied where appropriate.

Corroless EPF Buff	<b>DFT</b> 200 microns
Corroless RF35 (2006) Grey	200 microns
